Manhole Inspection Summary

Manhole # S33WW1013MH

Insp Date: **1/29/07 9:10 AM**

Location Address: **223 TUNBRIDGE RD**

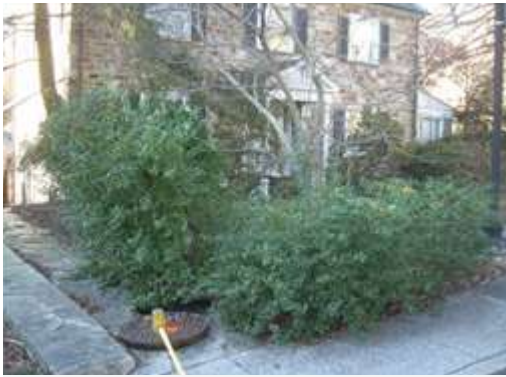
Location View

Comments **MH is located on a Private walkway.**

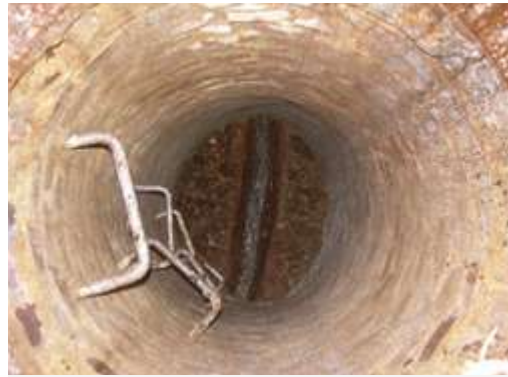
Top View

Bench debris.

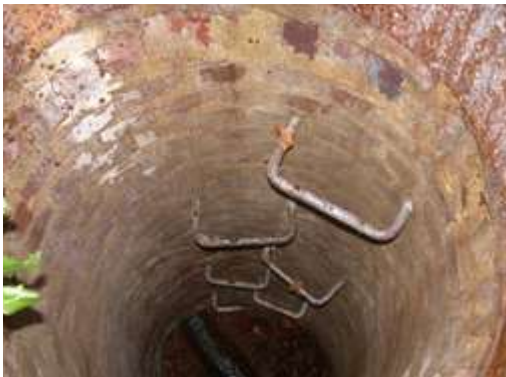
Defect

Frame leaks. Adjustment deterioration and infiltration. Barrel infiltration - other side.

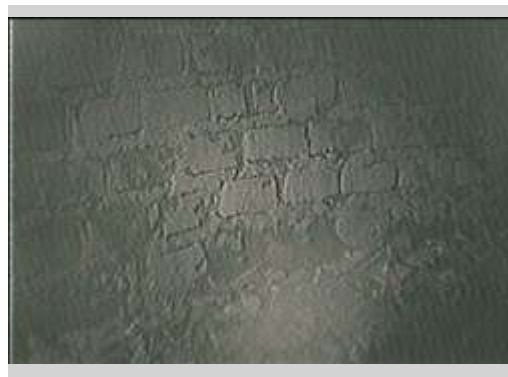
Defect

Barrel infiltration.

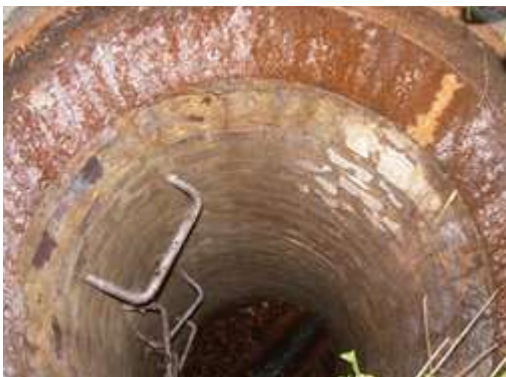
Defect

Frame leaks. Adjustment deterioration and infiltration. Barrel infiltration.

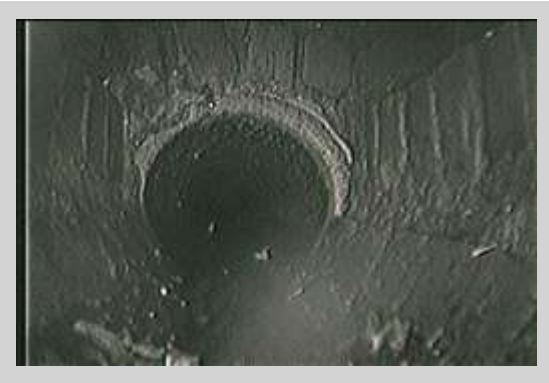
8 in. Circular Gravity Sewer Pipe Out @ 12 O'Clock

Infiltration: **Evidence** Pipe Seal Cond: **Unknown**

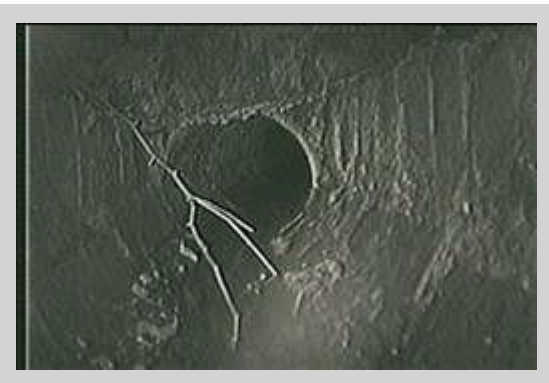
8 in. Circular Gravity Sewer Pipe In @ 7 O'Clock

Infiltration: **Evidence** Pipe Seal Cond: **Unknown**
